# NATIONAL TRANSPORTATION SAFETY BOARD

## SPECIAL INVESTIGATION REPORT

WING FAILURE OF BOEING 747-131  
NEAR MADRID, SPAIN  
MAY 9, 1976

AAR-78-12  
c. 3

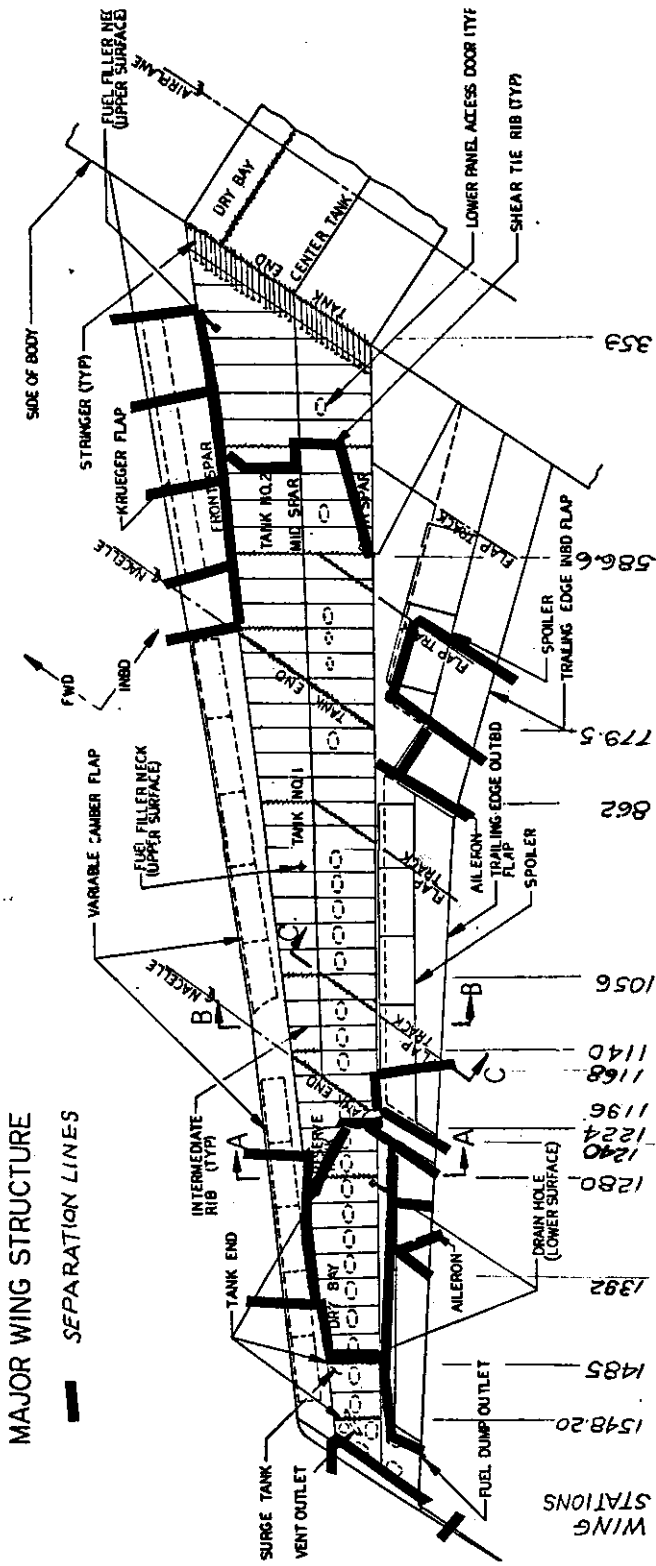
MAJOR WING STRUCTURE

Pitting and localized burn areas typical of lightning attachment damage were found on the left wingtip and on the vertical fin at the VOR antenna. The left wing had separated into 15 major pieces before ground impact and parts of it were found at each location of wreckage. (See drawing on page 31.)

The left wing outboard of the No. 1 engine position separated in three major pieces and along three lines of fracture. The left wingtip, a piece about 20 ft long, separated on a line parallel to the fuselage centerline and roughly halfway between the end of the wing and the No. 1 engine. A second line of separation was just outboard of the No. 1 engine and ran parallel to the rib centerlines. The third line of separation spanned between the first two and ran along the front spar. The wingtip, consisting of the high frequency antenna and coupler, also separated from the wing.
